**MISSION GALLERY SWANSEA  
DESIGN AND ACCESS STATEMENT**

**MISSION GALLERY**  
**Refurbishment and Redevelopment**

**Design and Access Statement**  
20150731\_FINAL

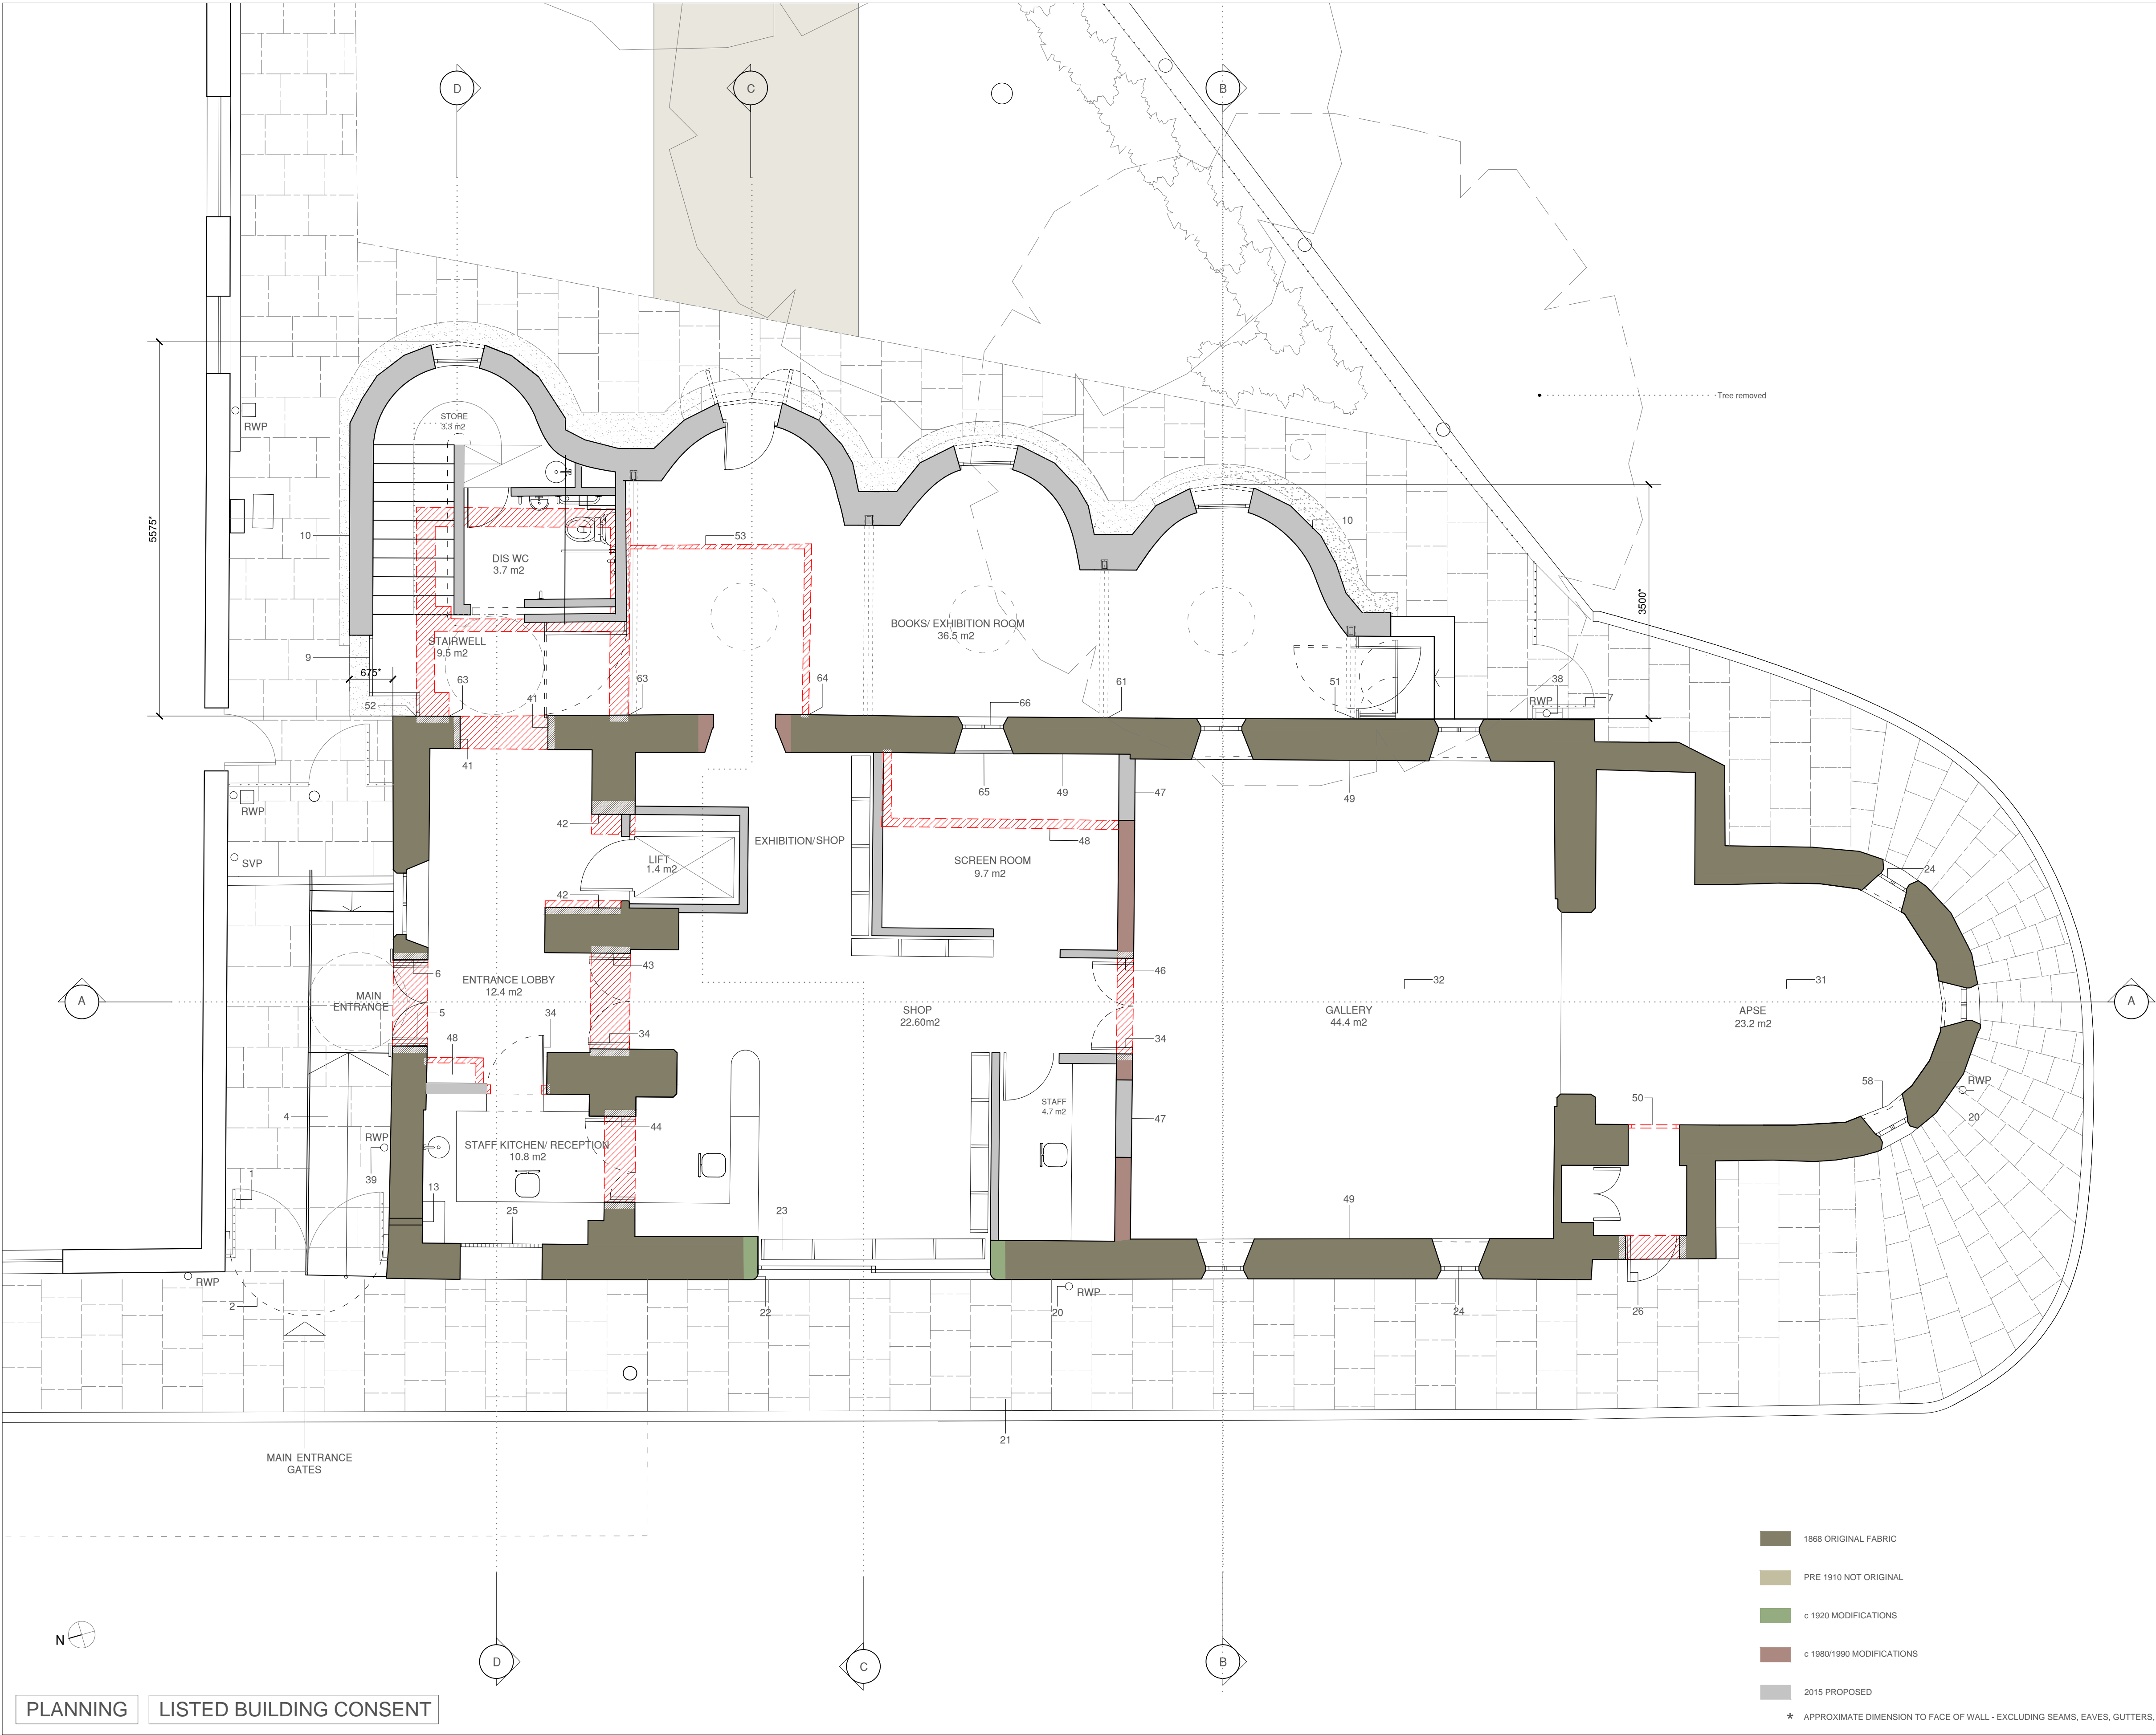
1. MAIN ENTRANCE GATES - MILD STEEL, PAINTED BLACK. HINGED OFF ADJACENT WALLS.
2. 3D SIGN - ORIEL MISSION - ON CURVING RHS OVER GATES - SATIN STAINLESS STEEL

3. 2D SIGN - ORIEL MISSION - SILKSCREENED TO REVERSE SIDE OF GLASS
4. ENTRY RAMP/STEPS - STONE PAVING, FLAMED ANTISLIP FINISH, TEXTURED + CONTRASTING STRIPS, EDGING / UPSTAND IN MILD STEEL, BALUSTRADE RAIL M5 TUBE, BALUSTERS M5 FLAT BAR, M5 PAINTED SATIN BLACK, STAINLESS STEEL CANOPY OVER SATIN POLISHED

65. ABUTTING BULKHEAD LINING PANEL
66. EXISTING WINDOW - REPLACED AS ITEM 24 - BUT WITH OBSCURED GLASS

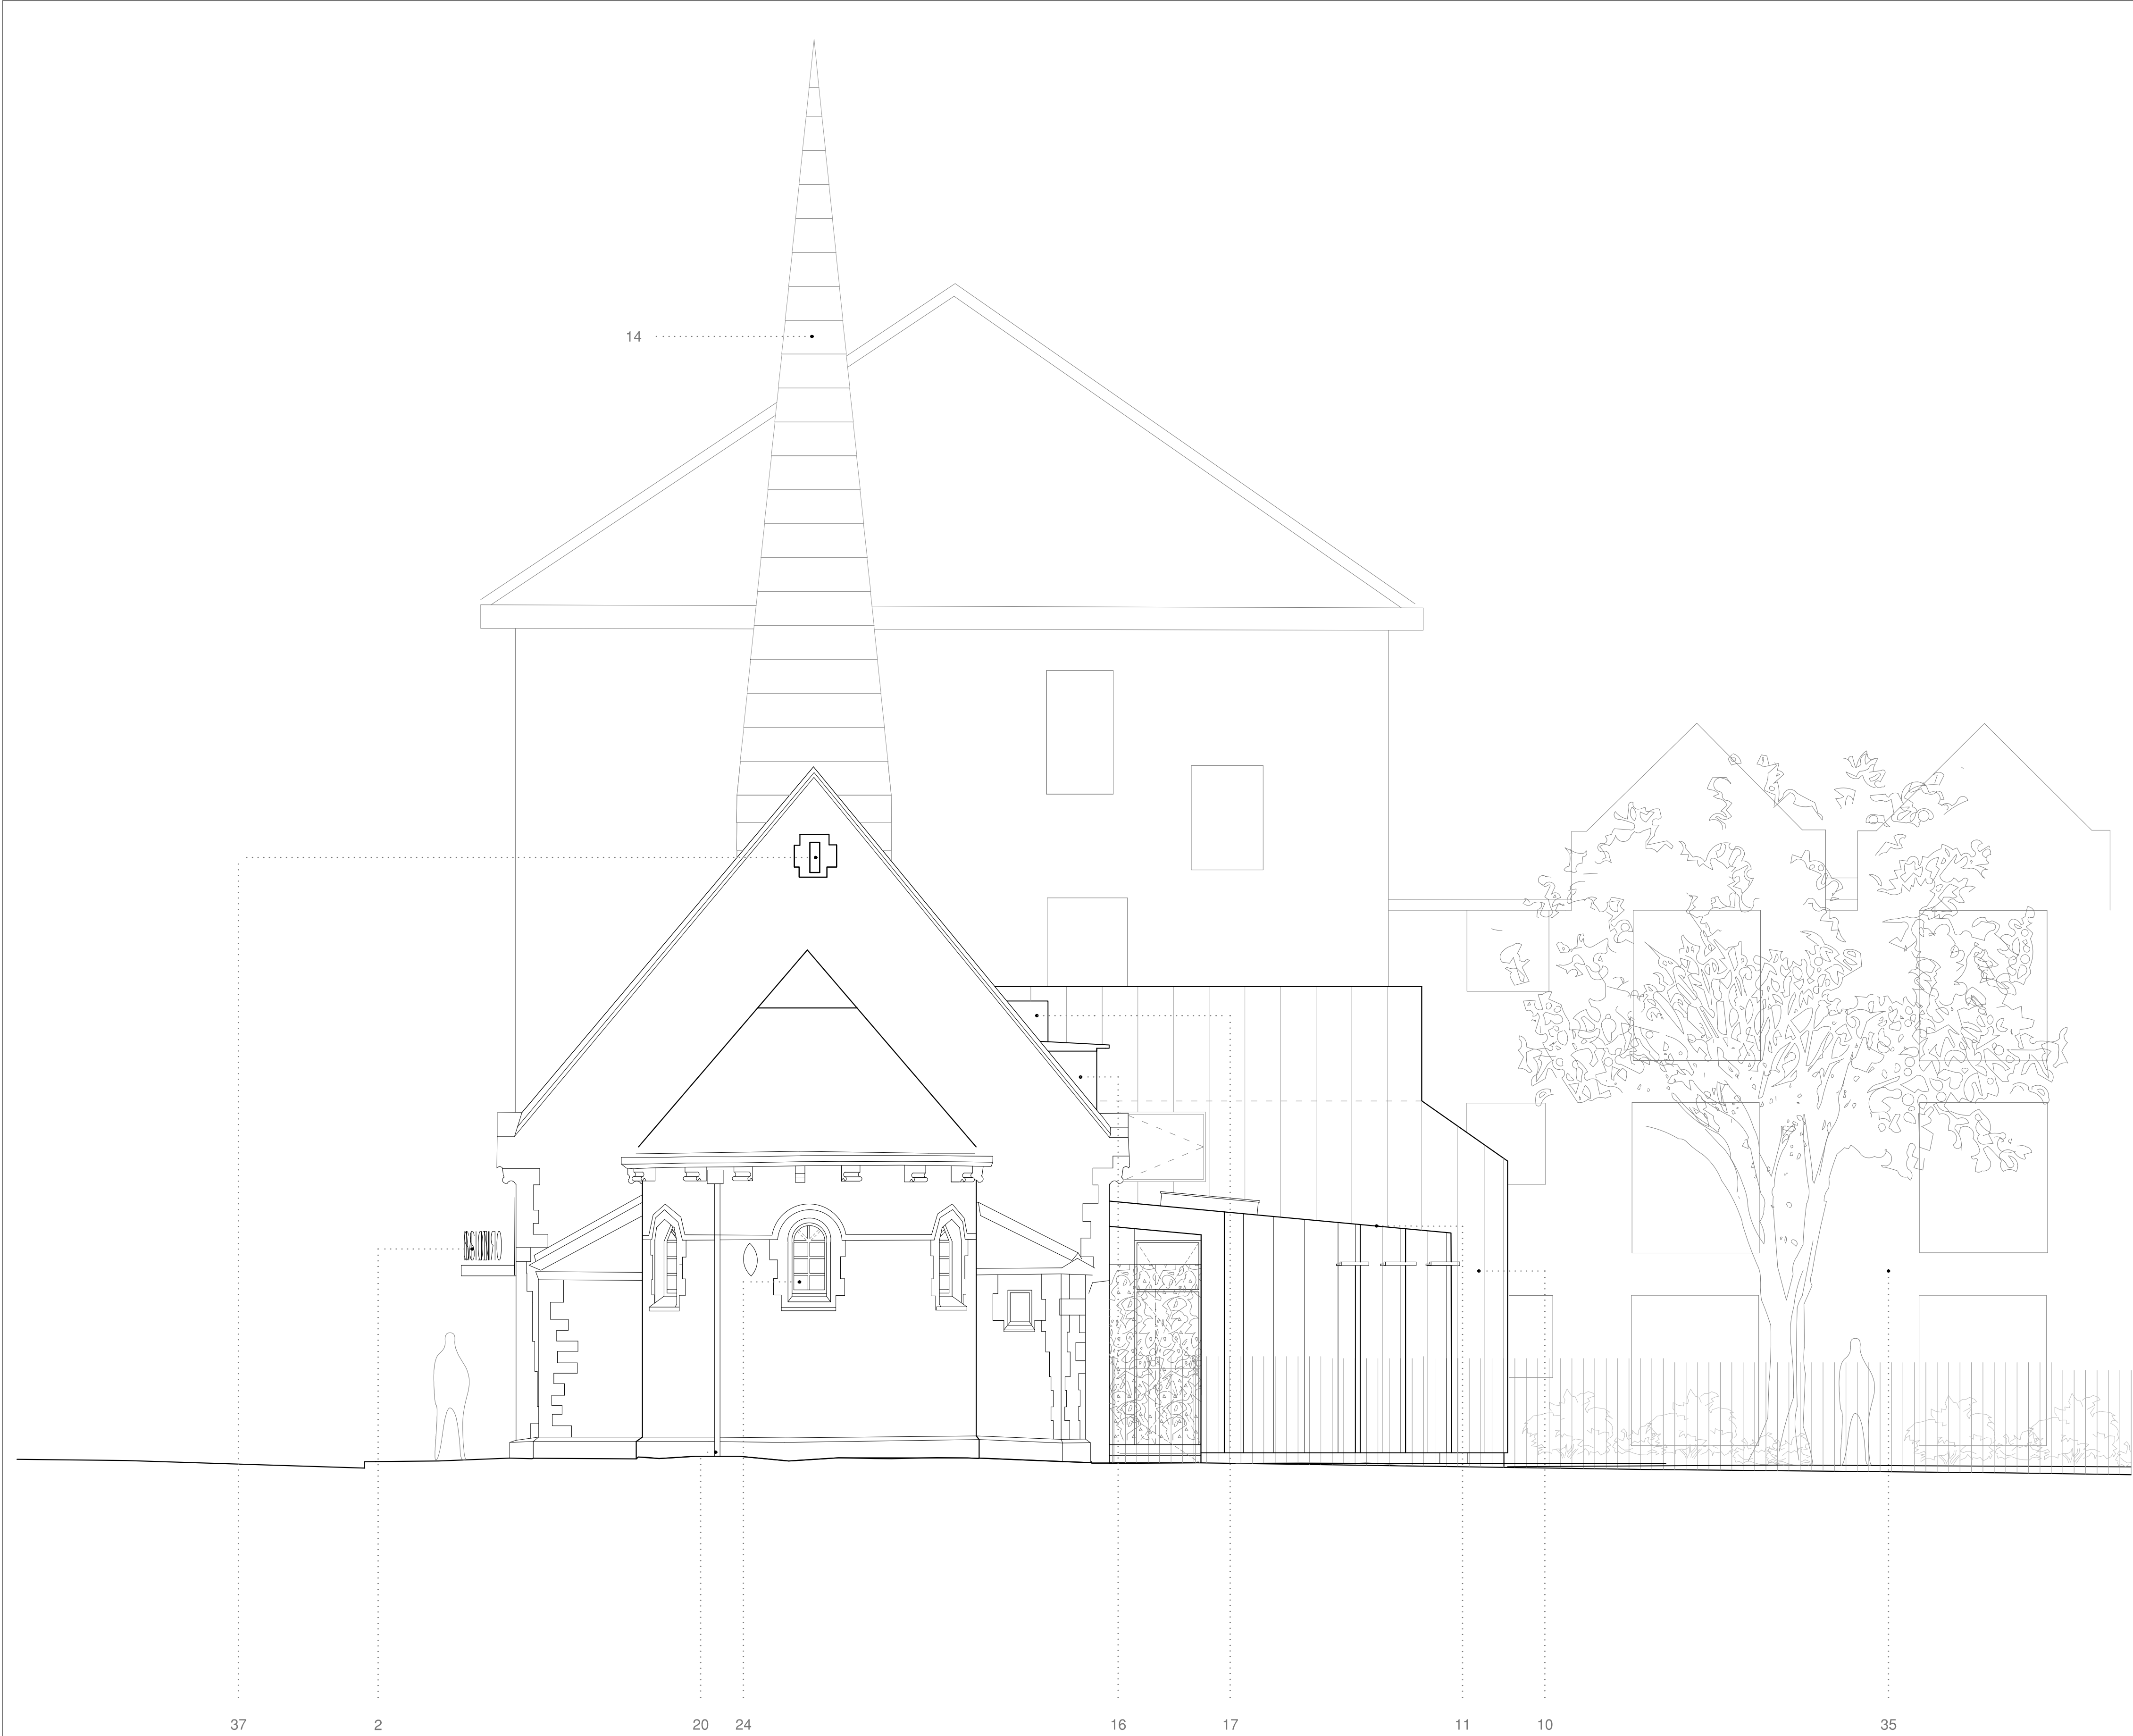
Scale @ A1 1:50 Scale @A3 1:100 stat. D job no. 209 date 01.07.15 drawing no. 018 revision P1

1. MAIN ENTRANCE GATES - MILD STEEL, PAINTED BLACK. HINGED OFF ADJACENT WALLS.
2. 3D SIGN - ORIEL MISSION - ON CURVING RHS OVER GATES - SATIN STAINLESS STEEL

- 2D SIGN - ORIEL MISSION - SILKSCREENED TO REVERSE SIDE OF GLASS
- ENTRY RAMP/STEPS - STONE PAVING, FLAMED ANTISLIP FINISH, TEXTURED + CONTRASTING STRIPS, EDGING / UPSTAND IN MILD STEEL, BALUSTRADE RAIL M5 TUBE, BALUSTERS M5 FLAT BAR, M5 PAINTED SATIN BLACK, STAINLESS STEEL CANOPY OVER SATIN POLISHED

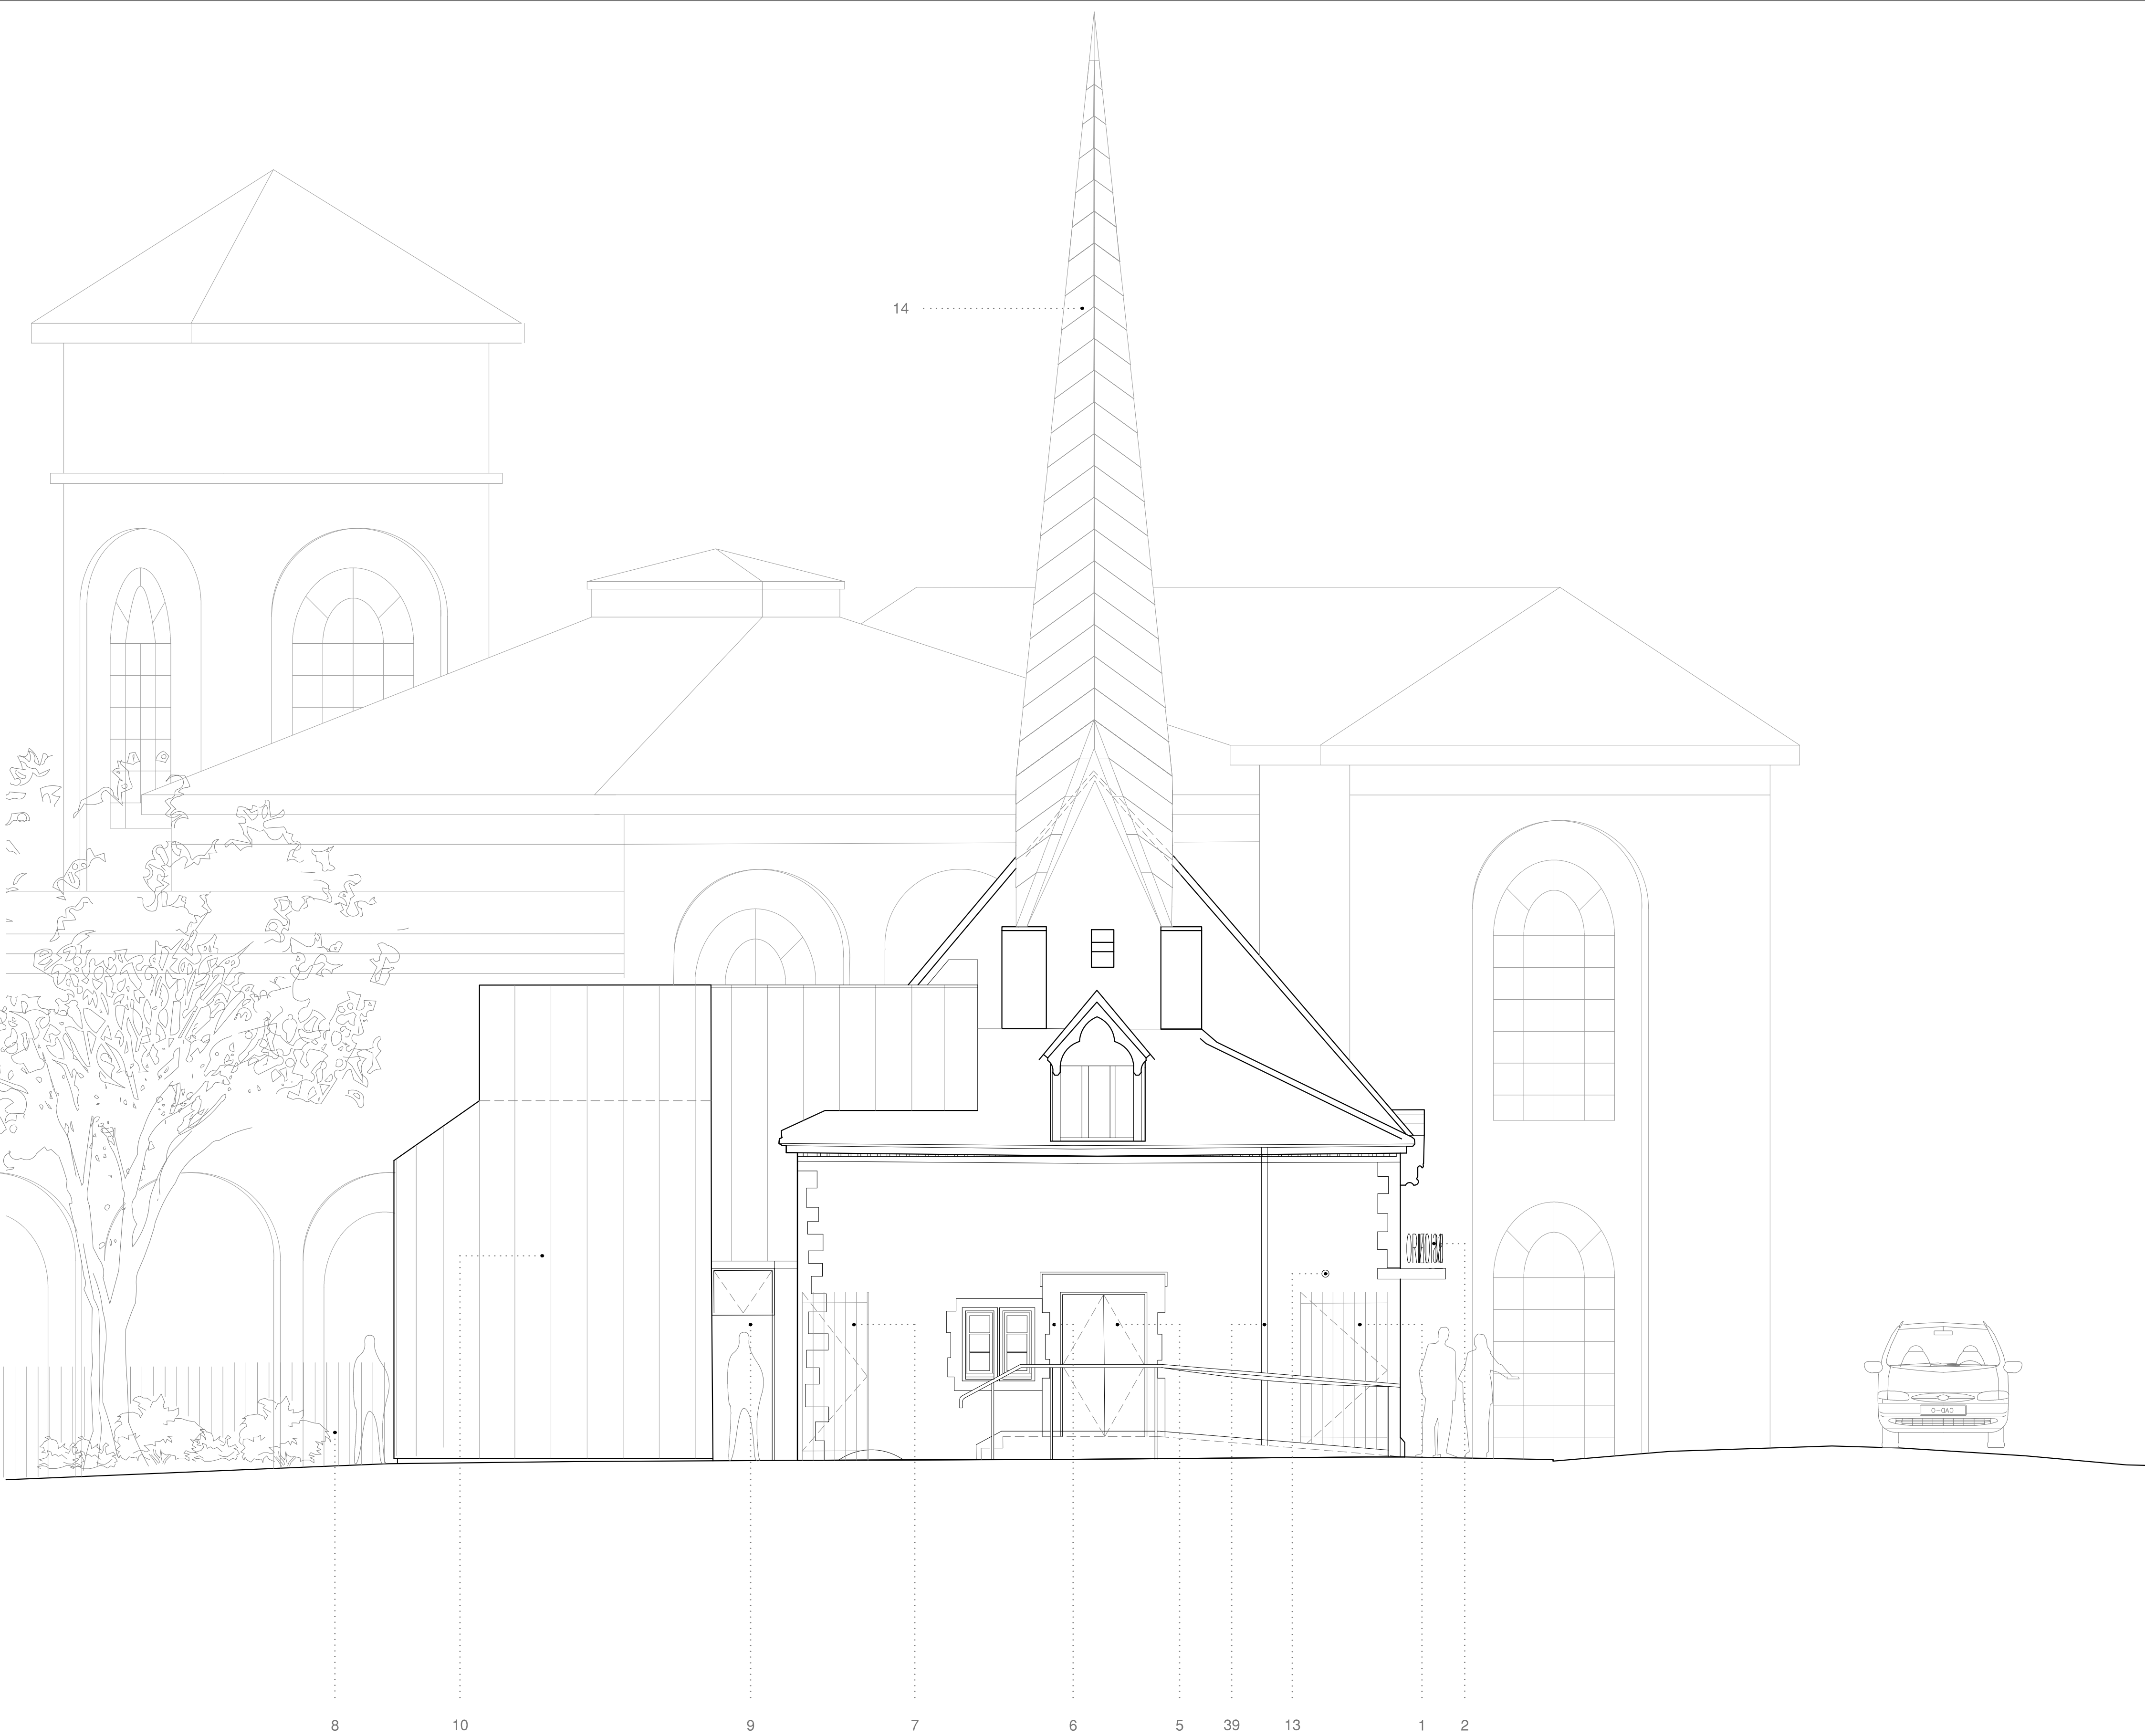
Scale @ A1 1:50 Scale @A3 1:100 stat. D job no. 209 date 01.07.15 drawing no. 020 revision P1

1. MAIN ENTRANCE GATES - MILD STEEL, PAINTED BLACK. HINGED OFF ADJACENT WALLS.
2. 3D SIGN - ORIEL MISSION - ON CURVING RHS OVER GATES - SATIN STAINLESS STEEL

- 2D SIGN - ORIEL MISSION - SILKSCREENED TO REVERSE SIDE OF GLASS
- ENTRY RAMPS/STEPS - STONE PAVING, FLAMED ANTISLIP FINISH, TEXTURED + CONTRASTING STRIPS, EDGING / UPSTAND IN MILD STEEL, BALUSTRADE RAIL MS TUBE, BALUSTERS MS FLAT/BAR, MS PAINTED SATIN BLACK, STAINLESS STEEL CANOPY OVER, SATIN POLISHED

66. EXISTING WINDOW - REPLACED AS ITEM 24 - BUT WITH OBSCURED GLASS

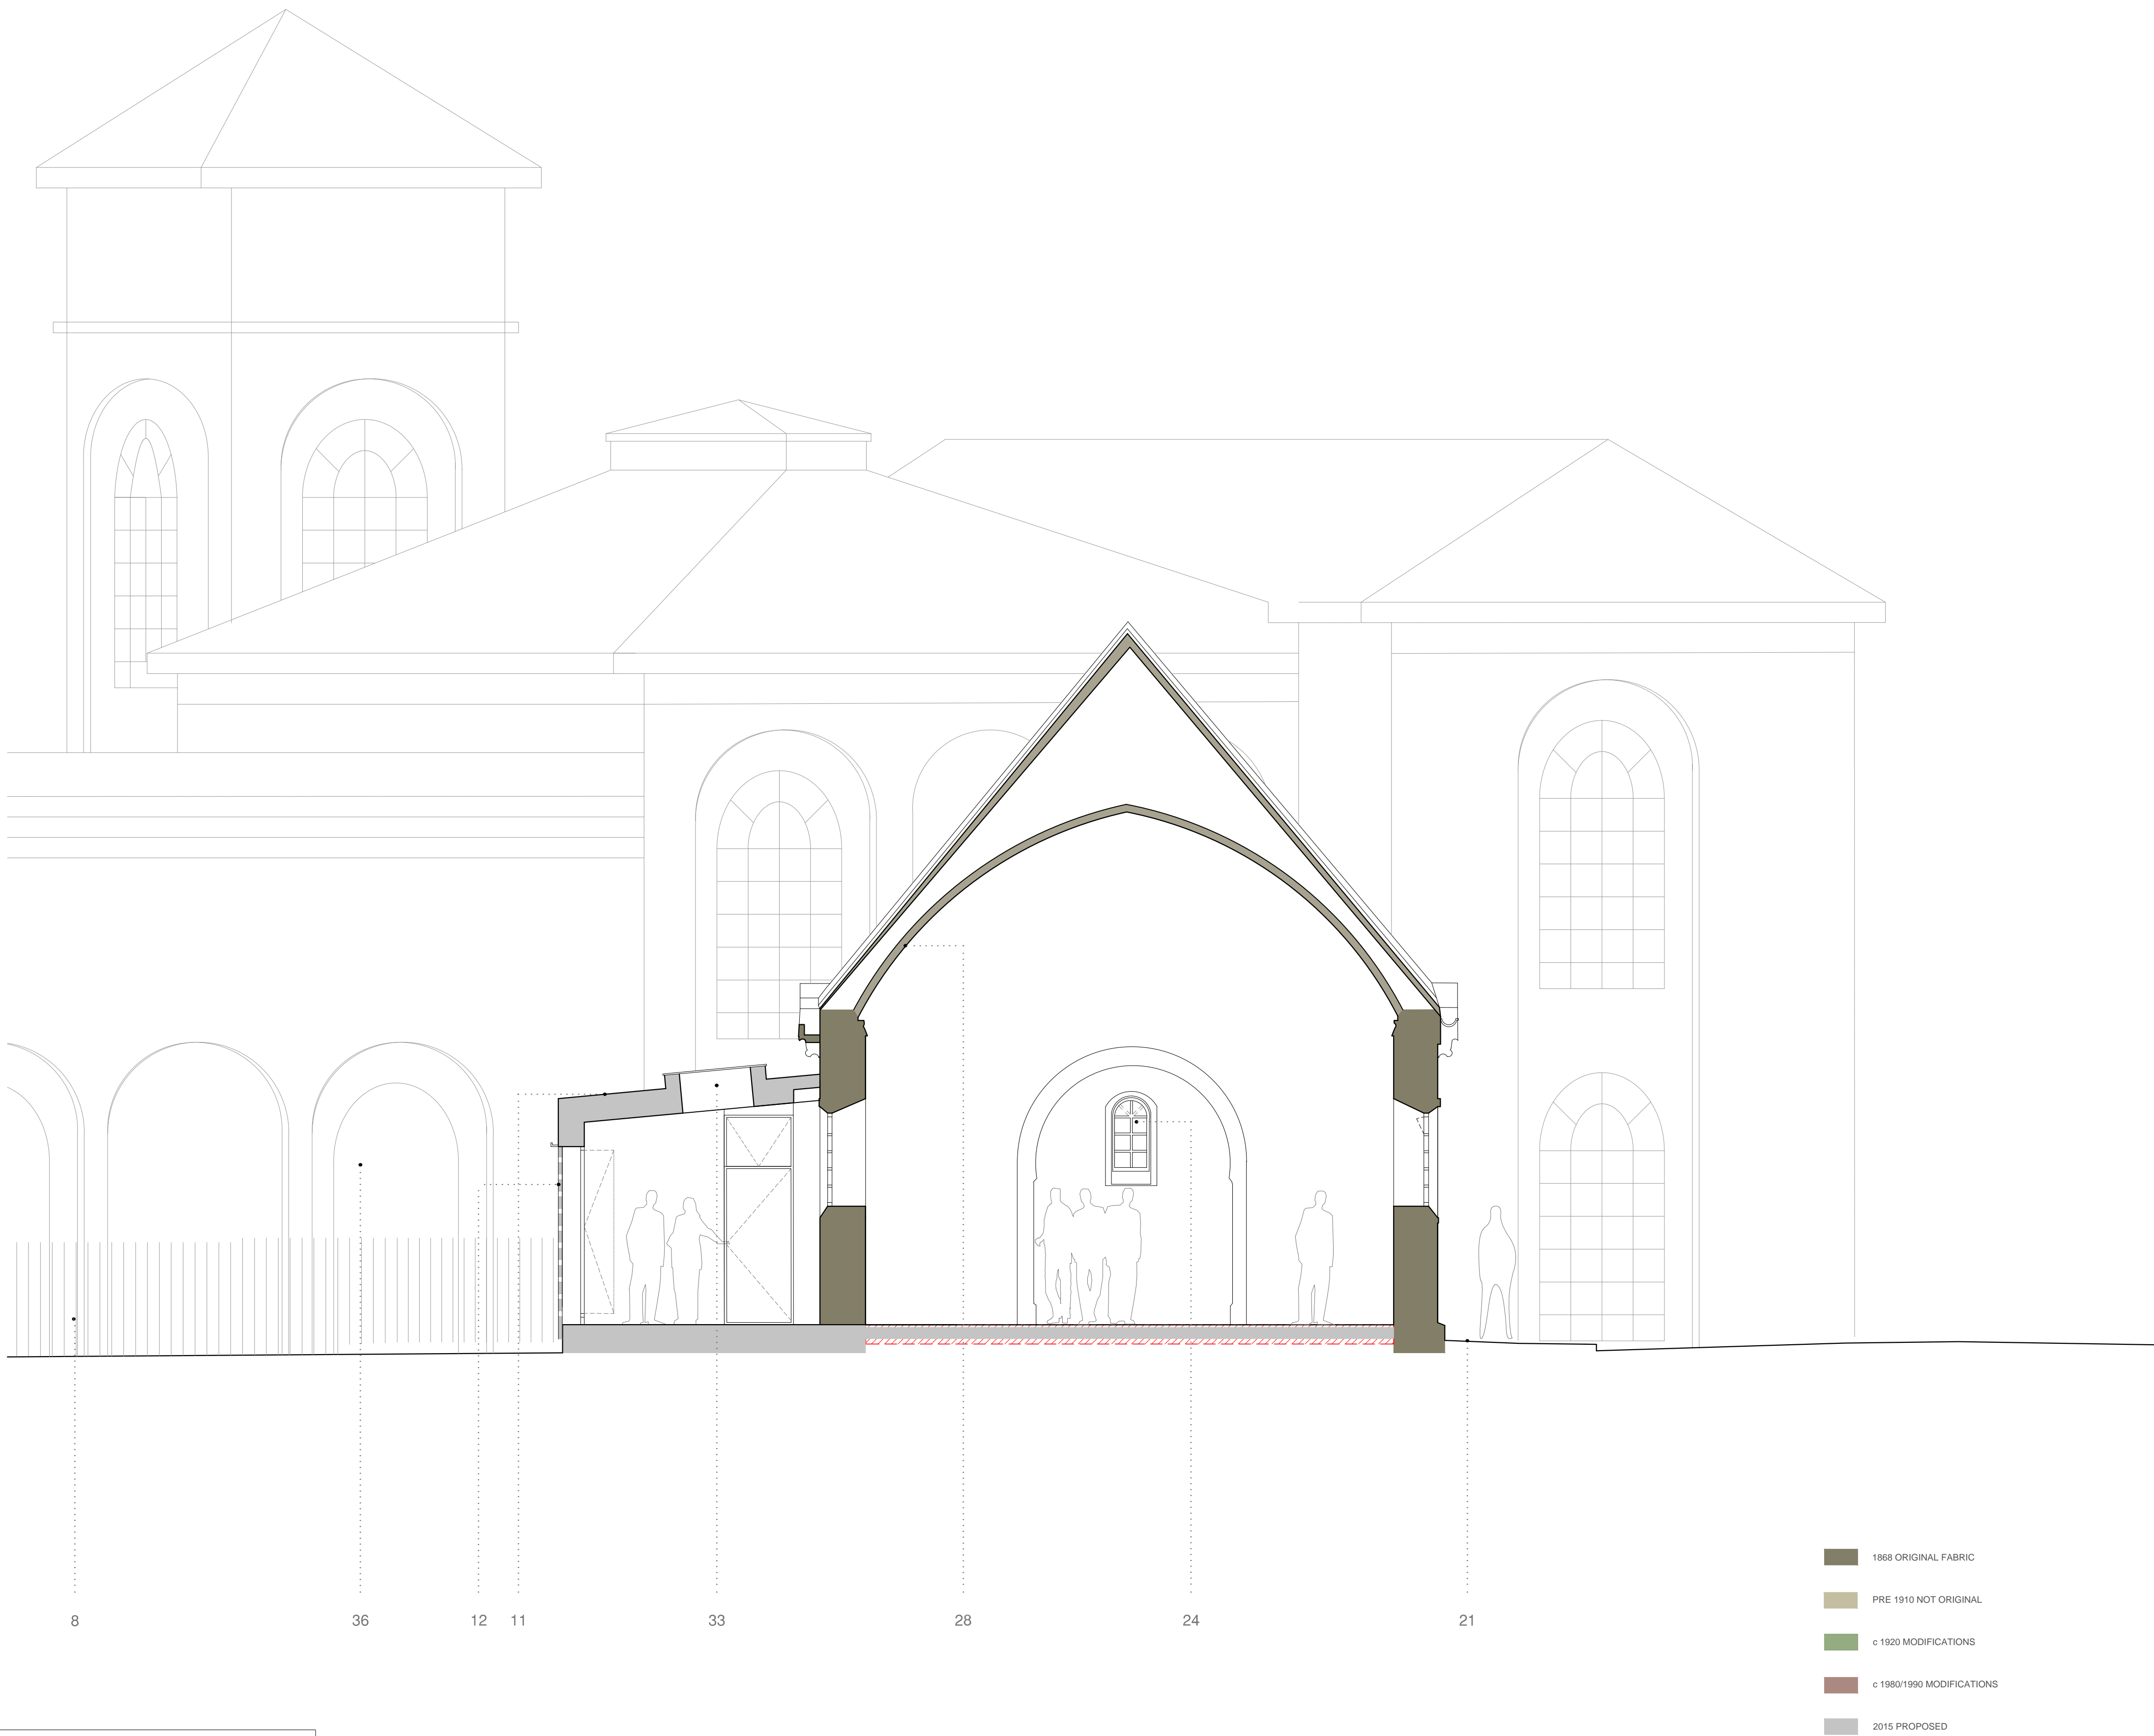
1. MAIN ENTRANCE GATES - MILD STEEL, PAINTED BLACK. HINGED OFF ADJACENT WALLS.
2. 3D SIGN - ORIEL MISSION - ON CURVING RHS OVER GATES - SATIN STAINLESS STEEL

- 2D SIGN - ORIEL MISSION - SILKSCREENED TO REVERSE SIDE OF GLASS
- ENTRY RAMP/STEPS - STONE PAVING, FLAMED ANTISLIP FINISH, TEXTURED + CONTRASTING STRIPS, EDGING / UPSTAND IN MILD STEEL, BALUSTRADE RAIL M5 TUBE, BALUSTERS M5 FLAT BAR, M5 PAINTED SATIN BLACK, STAINLESS STEEL CANOPY OVER SATIN POLISHED

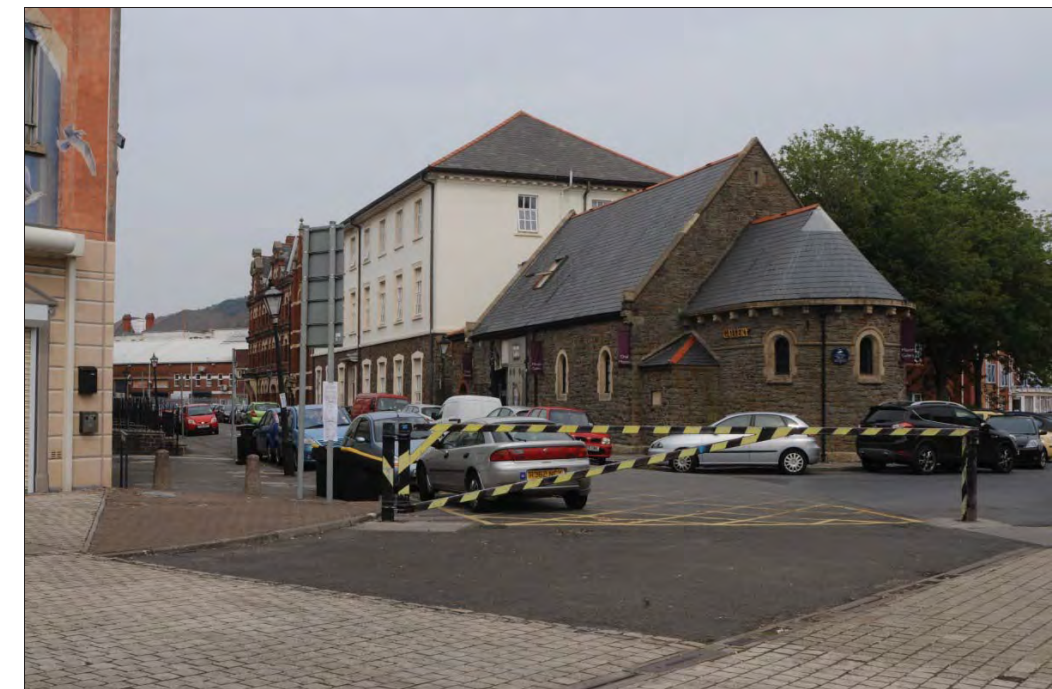
Figure 3: 3D Model image showing existing Mission Gallery and critical adjacent buildings, namely the south-facing façades of Gloucester House and Marina.
